RAKIČAN MANOR AS A MONUMENT OF PROMINENCE IN TIME AND SPACE

DVORAC RAKIČAN KAO ISTAKNUTI SPOMENIK U VREMENU I PROSTORU

Professional paper / Stručni rad

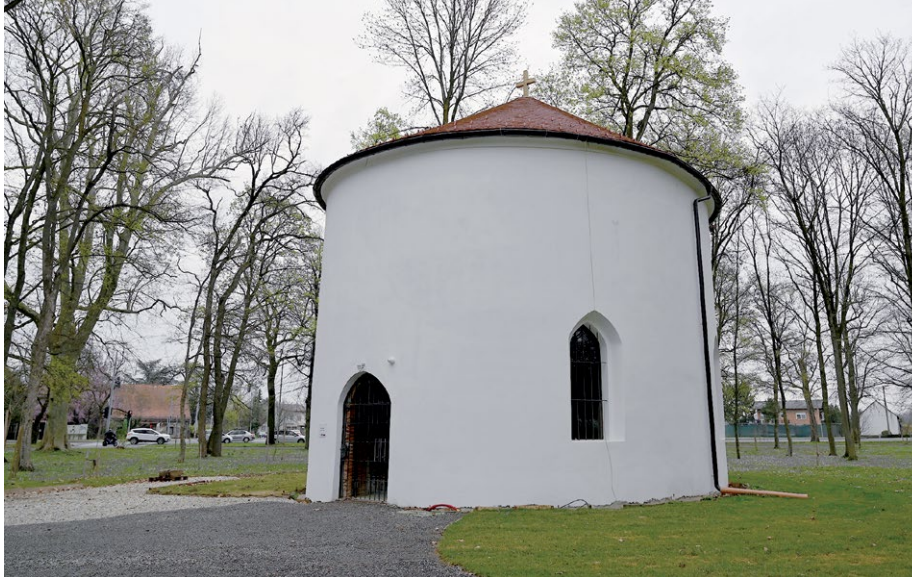
Fig. 2 The burial chapel has withstood despite poor maintenance over time and was restored in 2021 as part of the Living Heritage project (LAS programme) with the financial support of the Municipality of Murska Sobota (photography by Tajda Benko).

The small oval building is vaulted and features narrow windows with pointed arches. Inside, a tomb housed the remains of some members of the Batthyány family. At the end of the Second World War in 1945, the chapel was raided and almost entirely demolished as part of systematic destruction carried out by the new local authorities. Until recently, it was in a rather fragile state, but now, due to increased awareness, it is undergoing revitalization once again through appropriate conservation interventions.

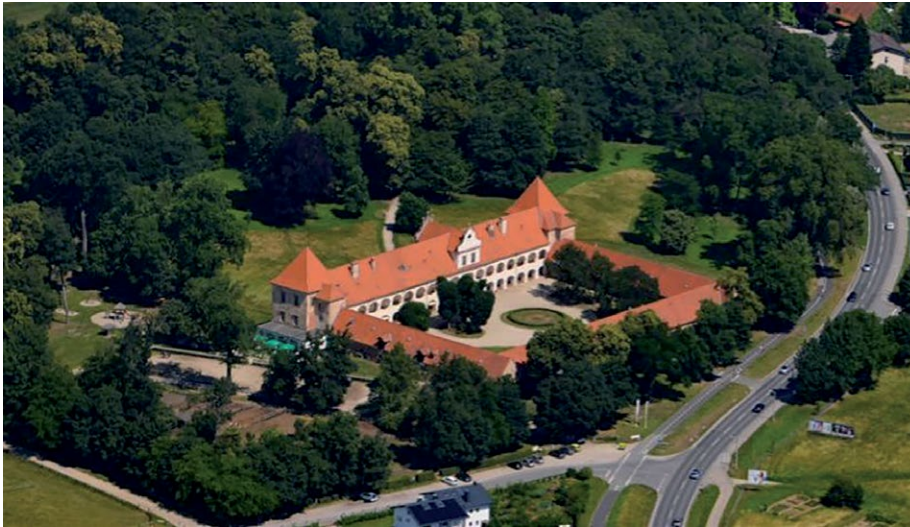
Fig. 4 Aerial photograph of the Rakičan Manor in a setting showing the enclosed design of the manor in the four tracts referred to throughout the article (photography by Borut Juvanec).

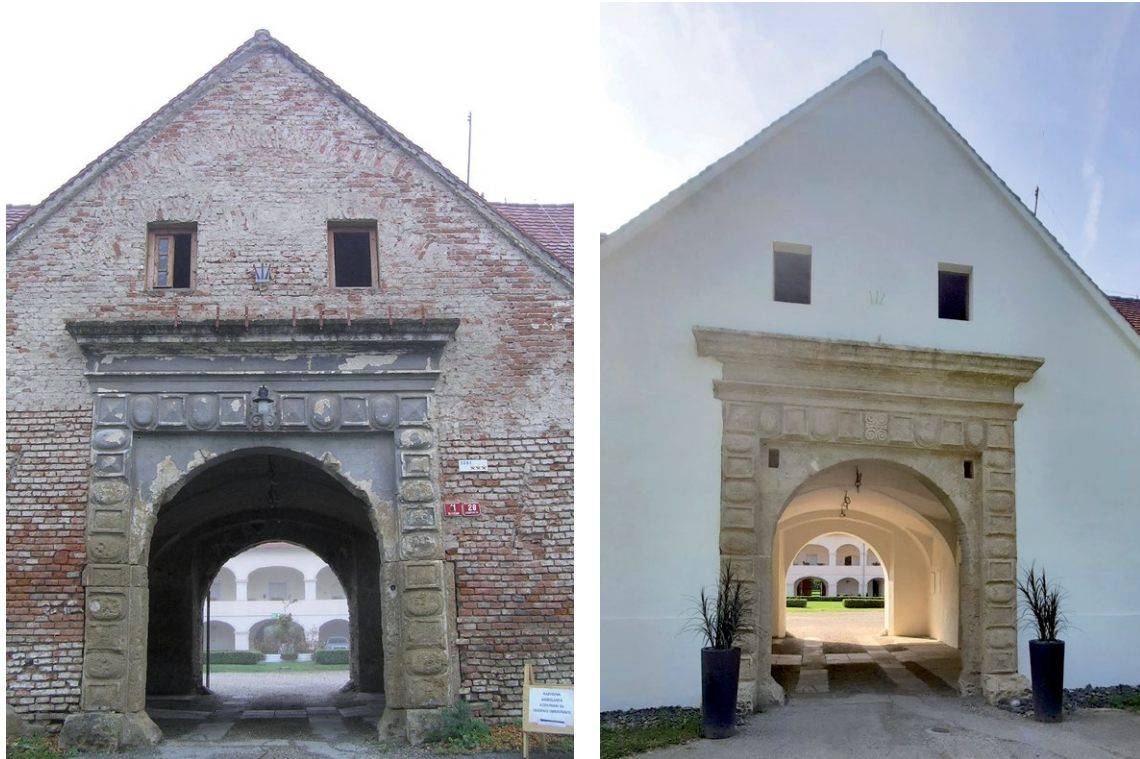
Fig. 5 The portal in the context of the entire eastern wing (formerly utility wing) before and after the restoration of the façade and portal (photographs by Tajda Benko and Andreja Benko).

The stone entrance portal has been significantly affected by usage, time, and climatic conditions. Today, visible cracks mar the stone, and in some areas, the stone has completely disintegrated. The portal has likely been dismantled and reassembled during renovations and reconstructions. Prolonged exposure to weather conditions has rendered the stone brittle and breakable, resulting in fractured decorative relief fields and the stone crumbling when touched. Additionally, the decorative protective paint layer has practically fallen off due to material incompatibility (sandstone and plater and paint). Similar to the burial chapel of the manor, the portal has undergone restoration.

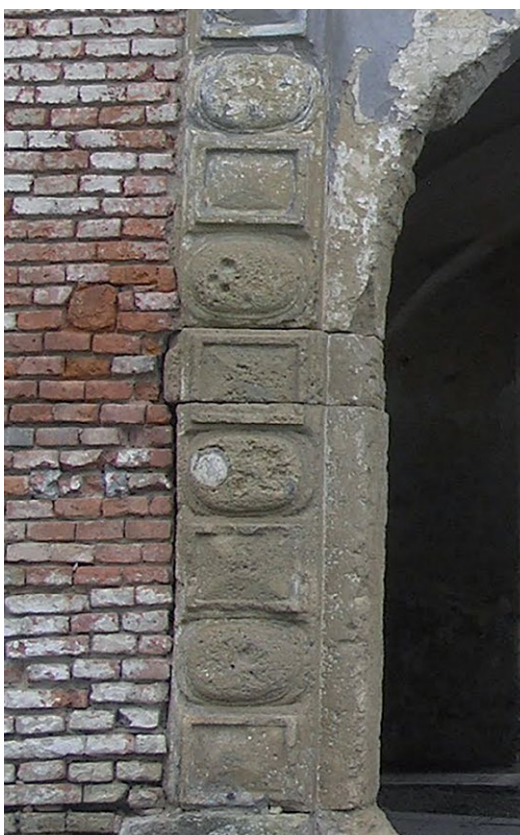
Fig. 6 Photograph of a single decorative field of the main portal of the Rakičan mansion prior to restoration, showing the stone structure and the base of the portal with an older grey coloured coating (photography by Tajda Benko).

The portal, crafted by an unknown stonemason, stands as one of the remaining late Renaissance elements of the former mansion, having been carved in 1631 and thus surviving the fire that devastated the entire mansion in the late 1740s. Despite being part of a rather modest country mansion, it boasts a vast rectangular design, measuring more than two and a half meters wide and just over three meters high, fully covered with carved ornamentation. The base of the portal consists of two stone blocks on either side, designed to allow carriages to pass through with ease. The outer rusticated framework is adorned with alternating rectangular and elliptical relief fields, protruding from the stone base of the portal (fig. 6).

Above the very center of the portal, a more elaborate, decorative carved element stands out among a series of relief ellipses and squares. The rectangular recessed part, featuring a semicircular entrance cor-

ridor, is not rusticated. Above the outer frame rises a horizontal lintel consisting of several sections, with a thin fluted band below the top of the lintel itself. The axially symmetrical side openings are still in place, suggesting that this was once the site of a lifting door, allowing the raising and lowering of lift gates. This confirms that the gates were located above a defensive moat, which is no longer there.

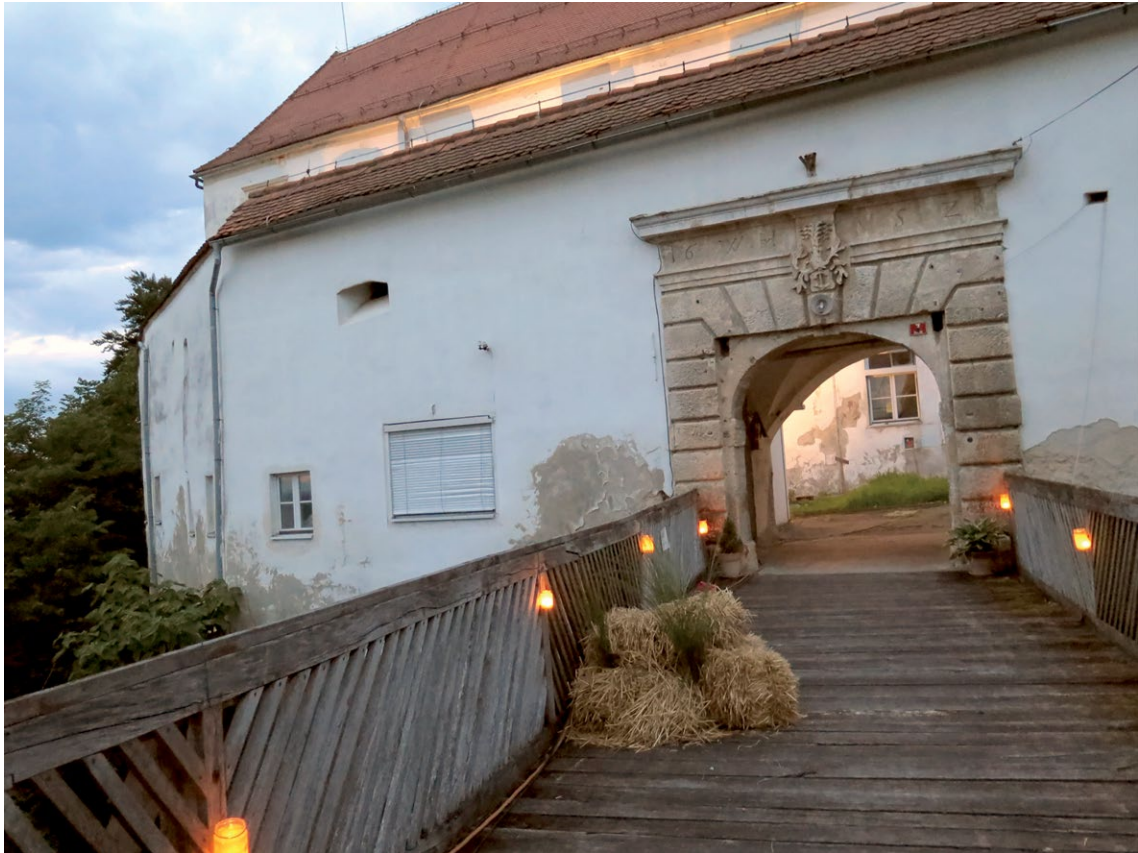
Fig. 7 A photograph of the entrance to Cmurek Castle in Trate (source: <https://www.seviqc-brezice.si/trate-grad-cmurek.html>). Given the way the stone portal and the system of lifting doors are designed, a parallel can be drawn with the portal at Rakičan Manor, where a similar gateway marks the entrance to the manor. It can be affirmed that the knowledge was transmitted and that, in all probability, the builders of the portal were from the same school or workshop, in spite of the fact that Cmurek Castle belonged to the Austrian part of the monarchy and Rakičan Castle to the Hungarian part.

The stone portal of the Rakičan manor can be compared with the portal of the Cmurek castle in Trate (Fig. 7), even though it belonged to a different family (among others to the Counts of Celje and later to the Counts of Stubenberg), this castle was likewise heavily reconstructed in the 16th century. The picture shows that a parallel can be drawn with the stone portal and the way it was constructed.

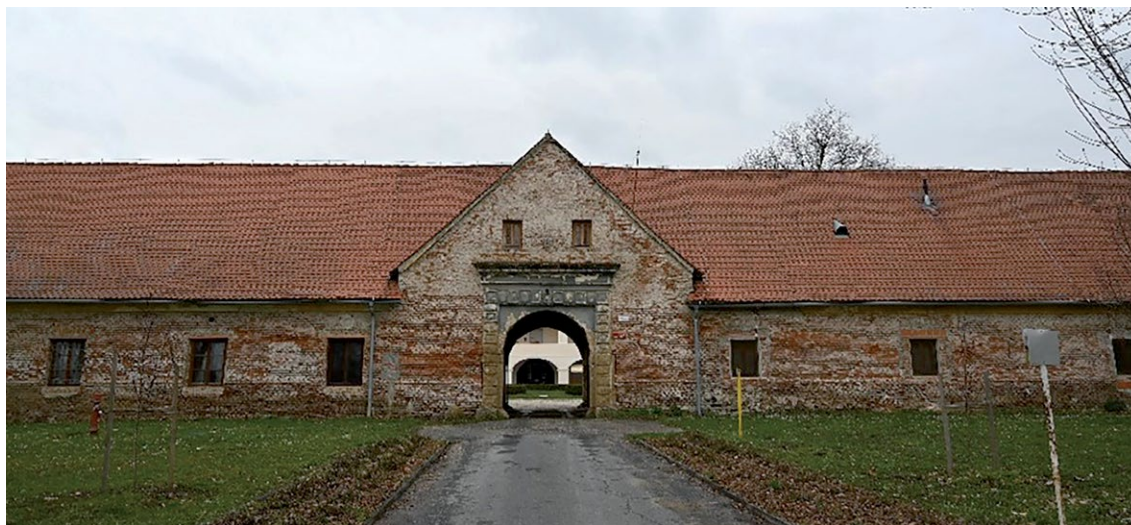
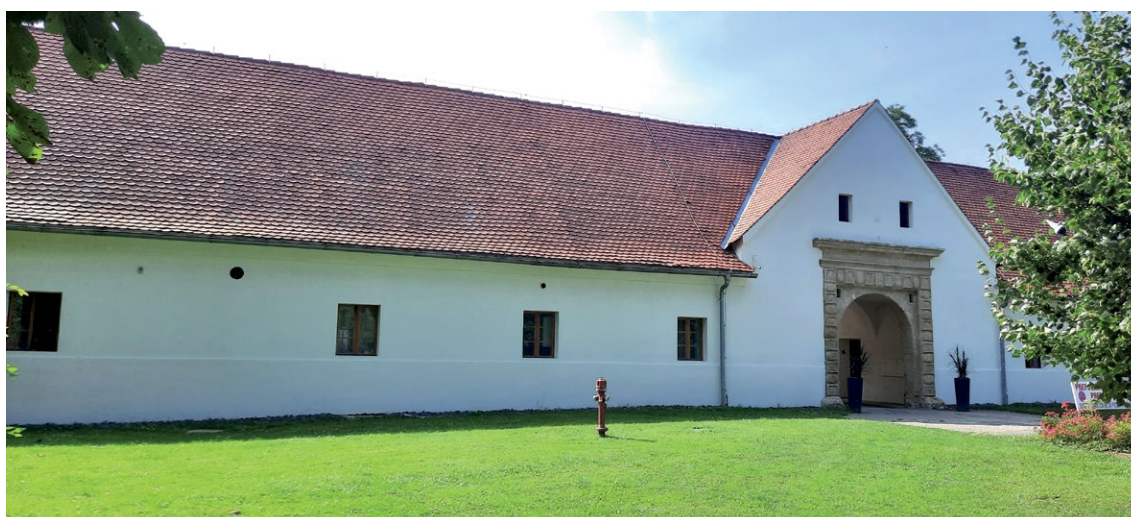
Fig. 8 Comparative photograph taken before the façade was restored, showing the bare structure of the building - the brick construction of the manor house, and later, when the façade has been completed and protects the construction of the building (photography by Tajda Benko).

The eastern wing, now adorned with a new façade, previously revealed the brick structure of the building, a traditional type of construction in Prekmurje (Fig. 8). Today, the entrance through the east part of the building serves as the main entrance for tourists, employees, and other guests visiting the manor.

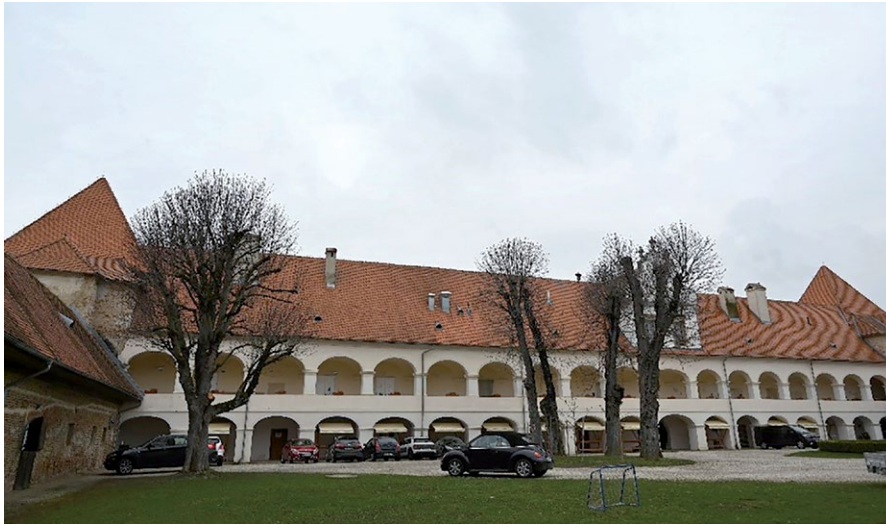
Fig. 9 The arcaded covered corridor with cross arches in the Rakičan manor, which provides access to various parts of the manor, including in bad weather (photography by Tajda Benko).

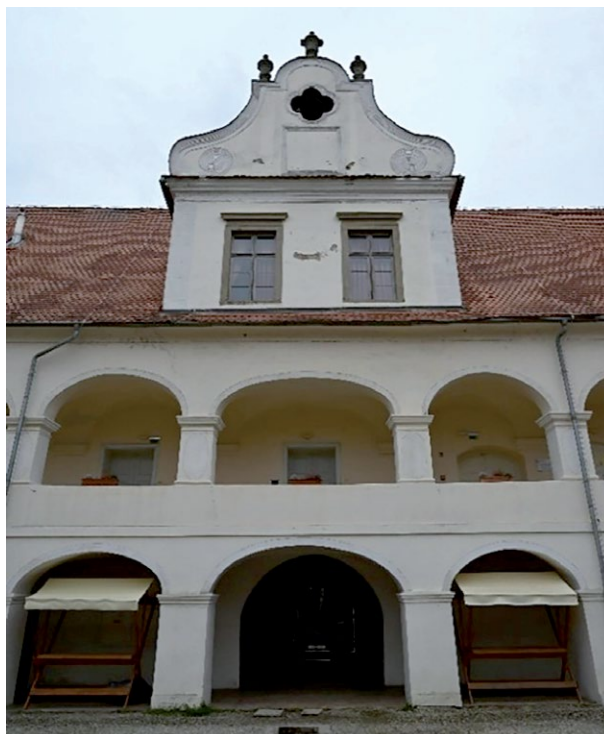
Fig. 10 The west, representative side of the Rakičan manor house (the oldest section), where a higher quality, more decorative side of the manor house was built, which connected it to the surrounding garden and park (photography by Tajda Benko).

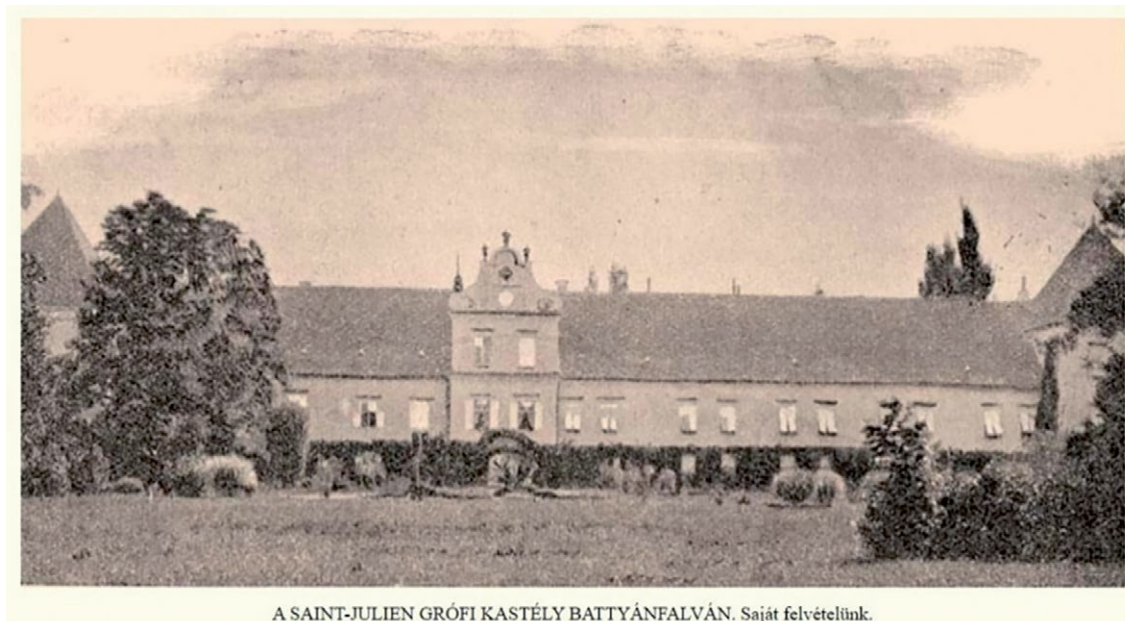
Fig. 11 This photograph was taken in 1898 at the west side of the manor house, from the adjacent park, showing the more representative entrance with a *avant-corpes*. The ivy covering the lower level of the mansion is also evident. According to the inscription on the photograph, *Saját felvételünk* ('personal photograph'), it was taken by Borovszky Samu (1860-1912), a Hungarian historian who became a member of the governing board of the Historical Society in 1889 and a corresponding member of the Academy since 1899 (source: <https://www.arcanum.com/hu/online-kiadvanyok/Borovszky-borovszky-samu-magyarorszag-varmegyei-es-varosai-1/vas-varmegye-1C4AE/vasvarmegye-kozsegei-1C5BD/battyanfalfa-saint-julien-kastely-1C629/> (4. 12. 2023)).

One of the very few preserved photographs of the Rakičan mansion dates back to the late 19th century when the property was owned by Count Johann Clemens Saint-Julien-Wallsee. The photograph offers a glimpse into the state of the mansion as it appears today (Fig. 11)

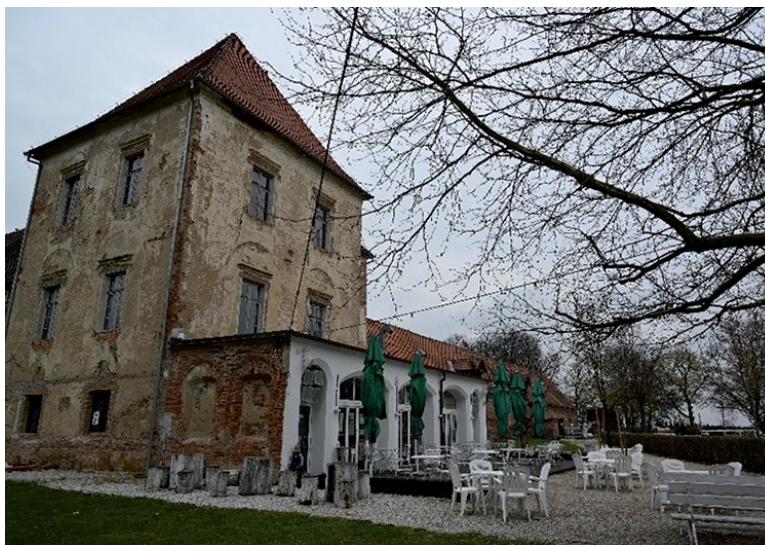
Fig. 13 Present-day view of the southern part of the building, where the stables, manege and café are located (photography by Tajda Benko).

has been preserved through multiple restorations. The rooms' functions were altered, and the Baroque furnishings were either sold, stolen, or destroyed when the manor became national property. In the 1980s, the south wing was transformed into an equestrian club, including a manege, stables, and a café (Fig. 13). In 1990, the roof was restored, and the arcaded corridor reconstructed, offering new hope for the general revitalization of the monument.
